Failure Analysis of Failed PMTs

Progress report

Failed PMT ZL1193

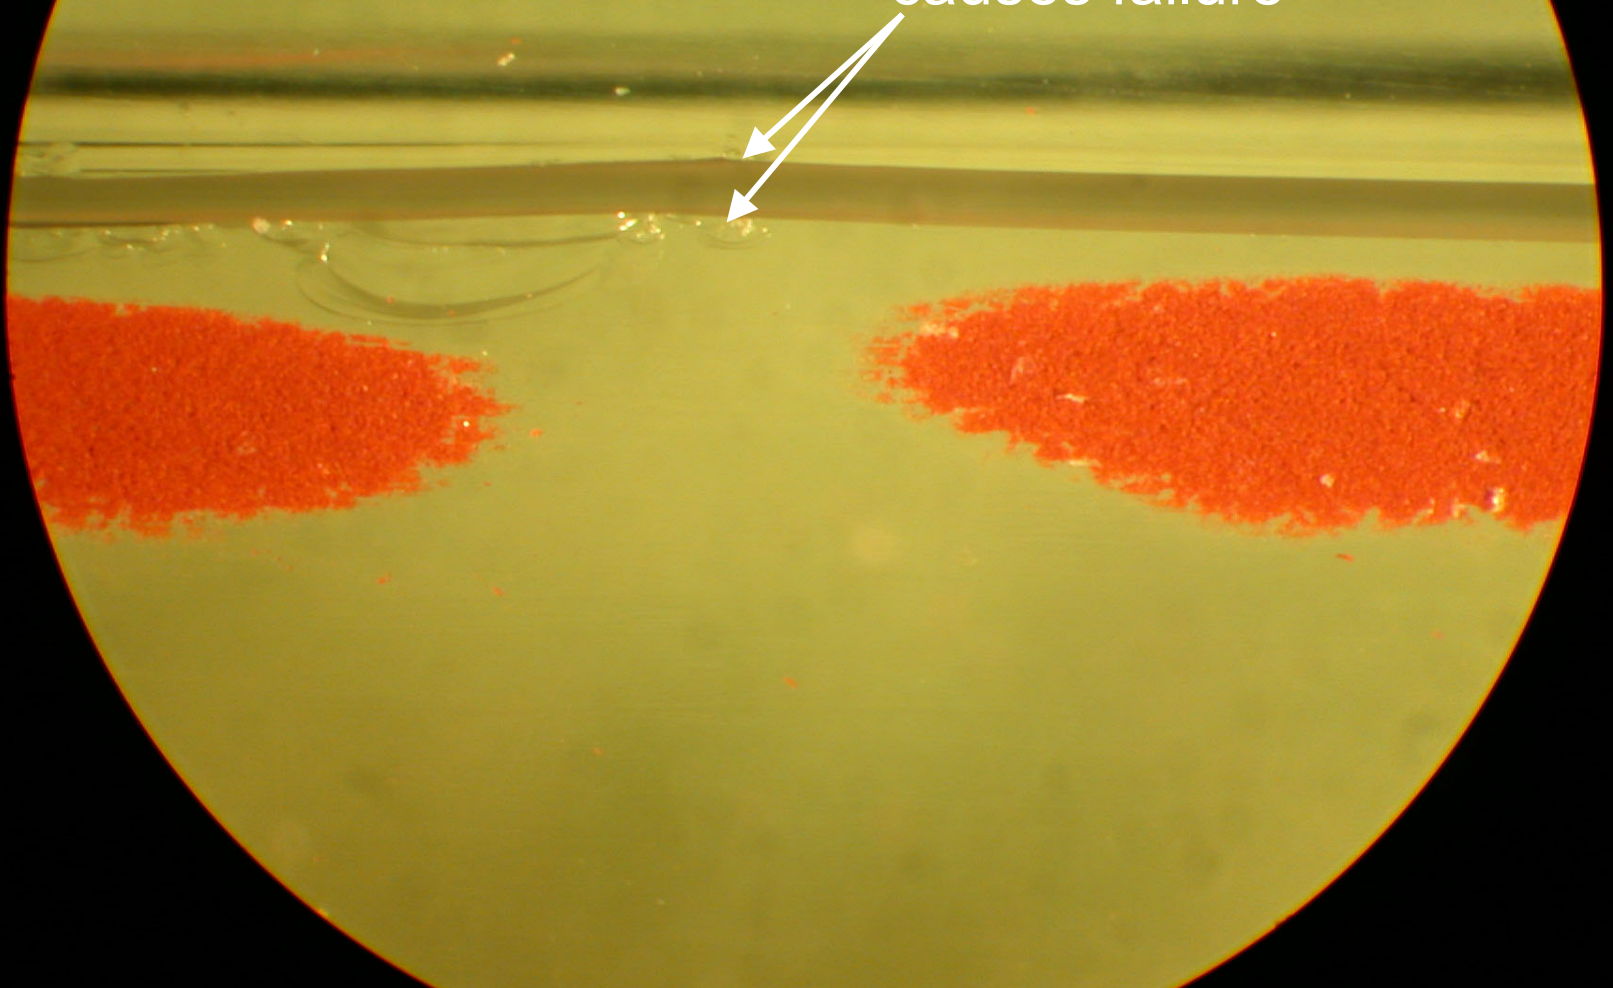
- Fracture origin identified as a chipping/score on outside surface, about 27 mm from base
- Inspection before potting: rated “Worst”, 3 score lines on the outside surface in the middle (1/3) region, severe inside scores

Outside surface of PMT ZL1193

Defect that
causes failure

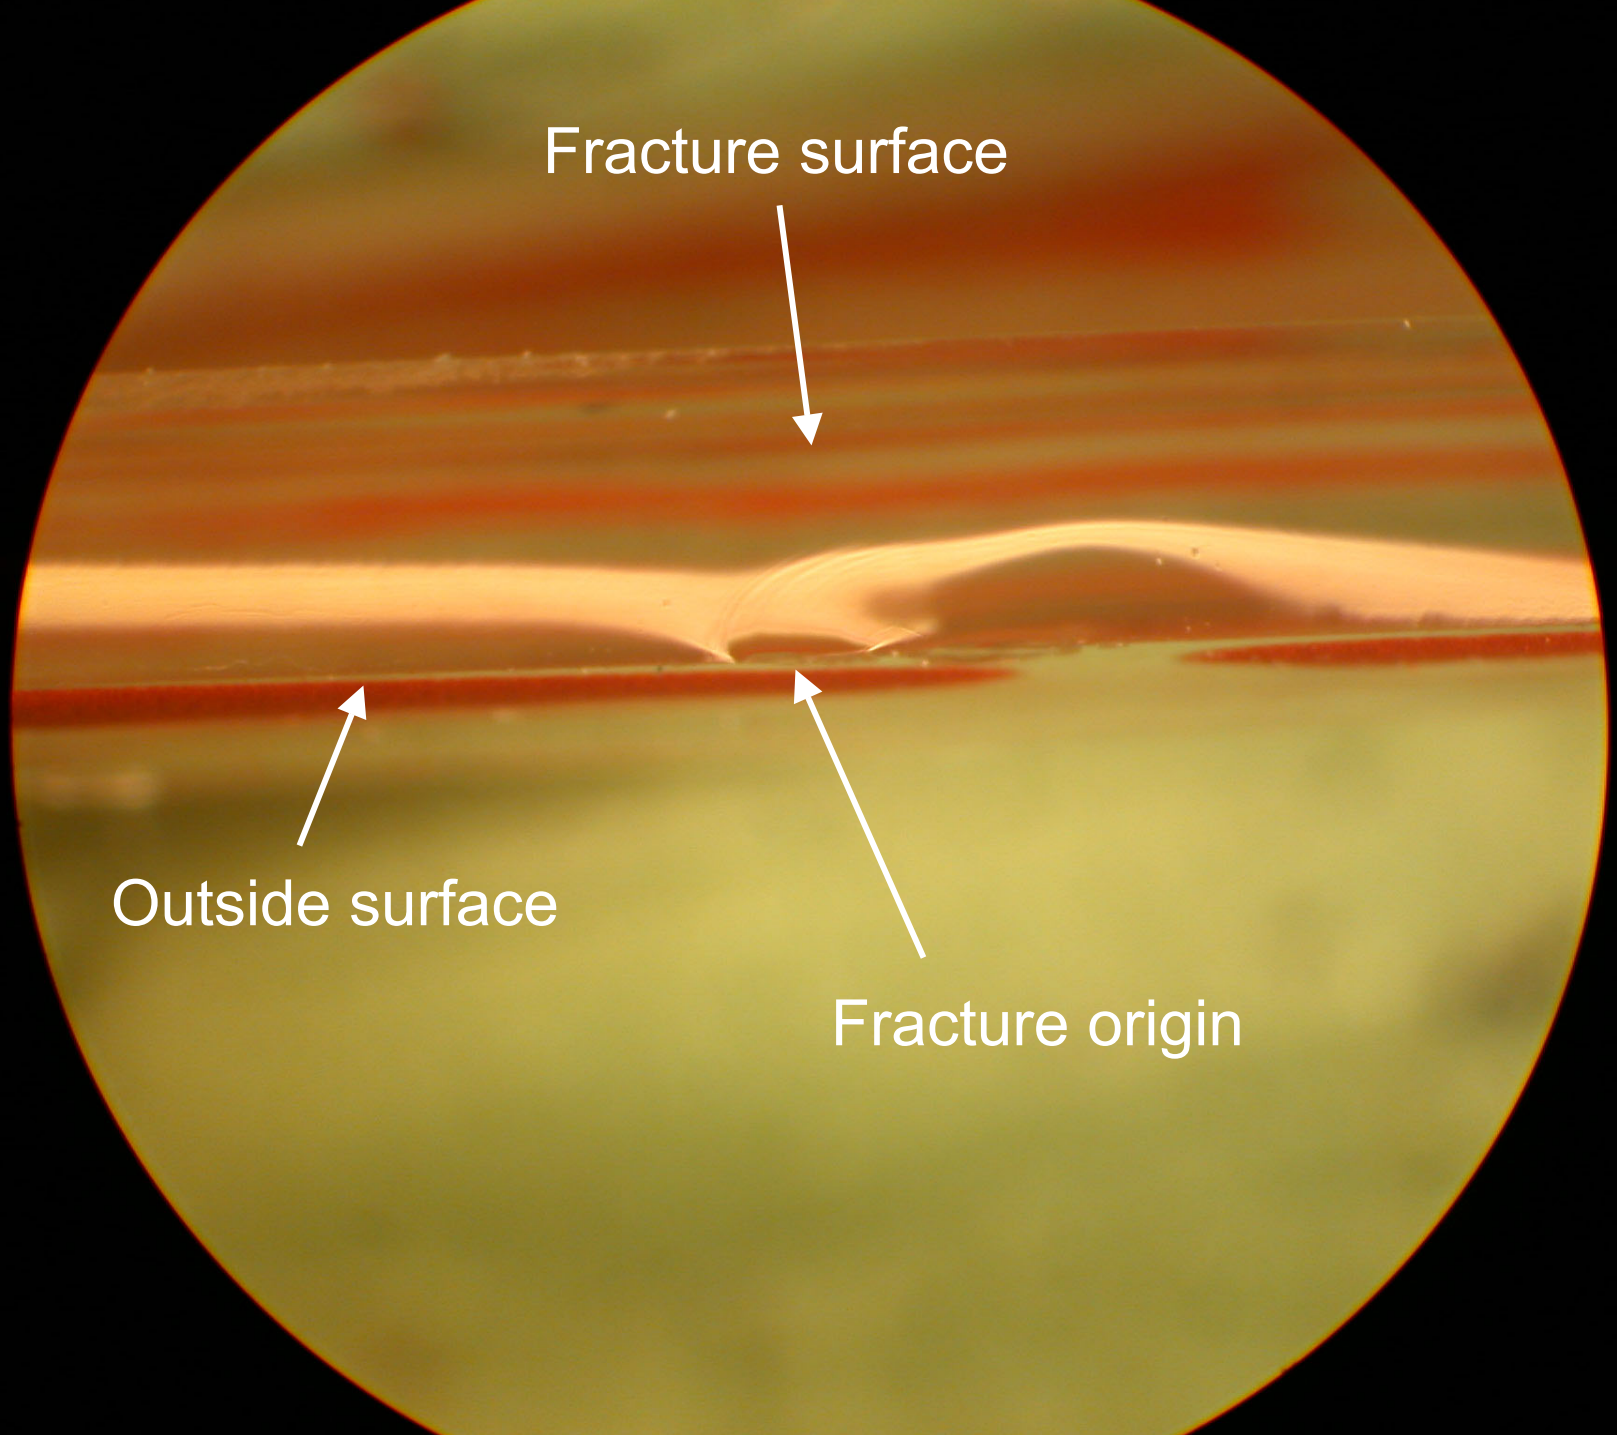
Fracture surface

Outside surface

Fracture origin

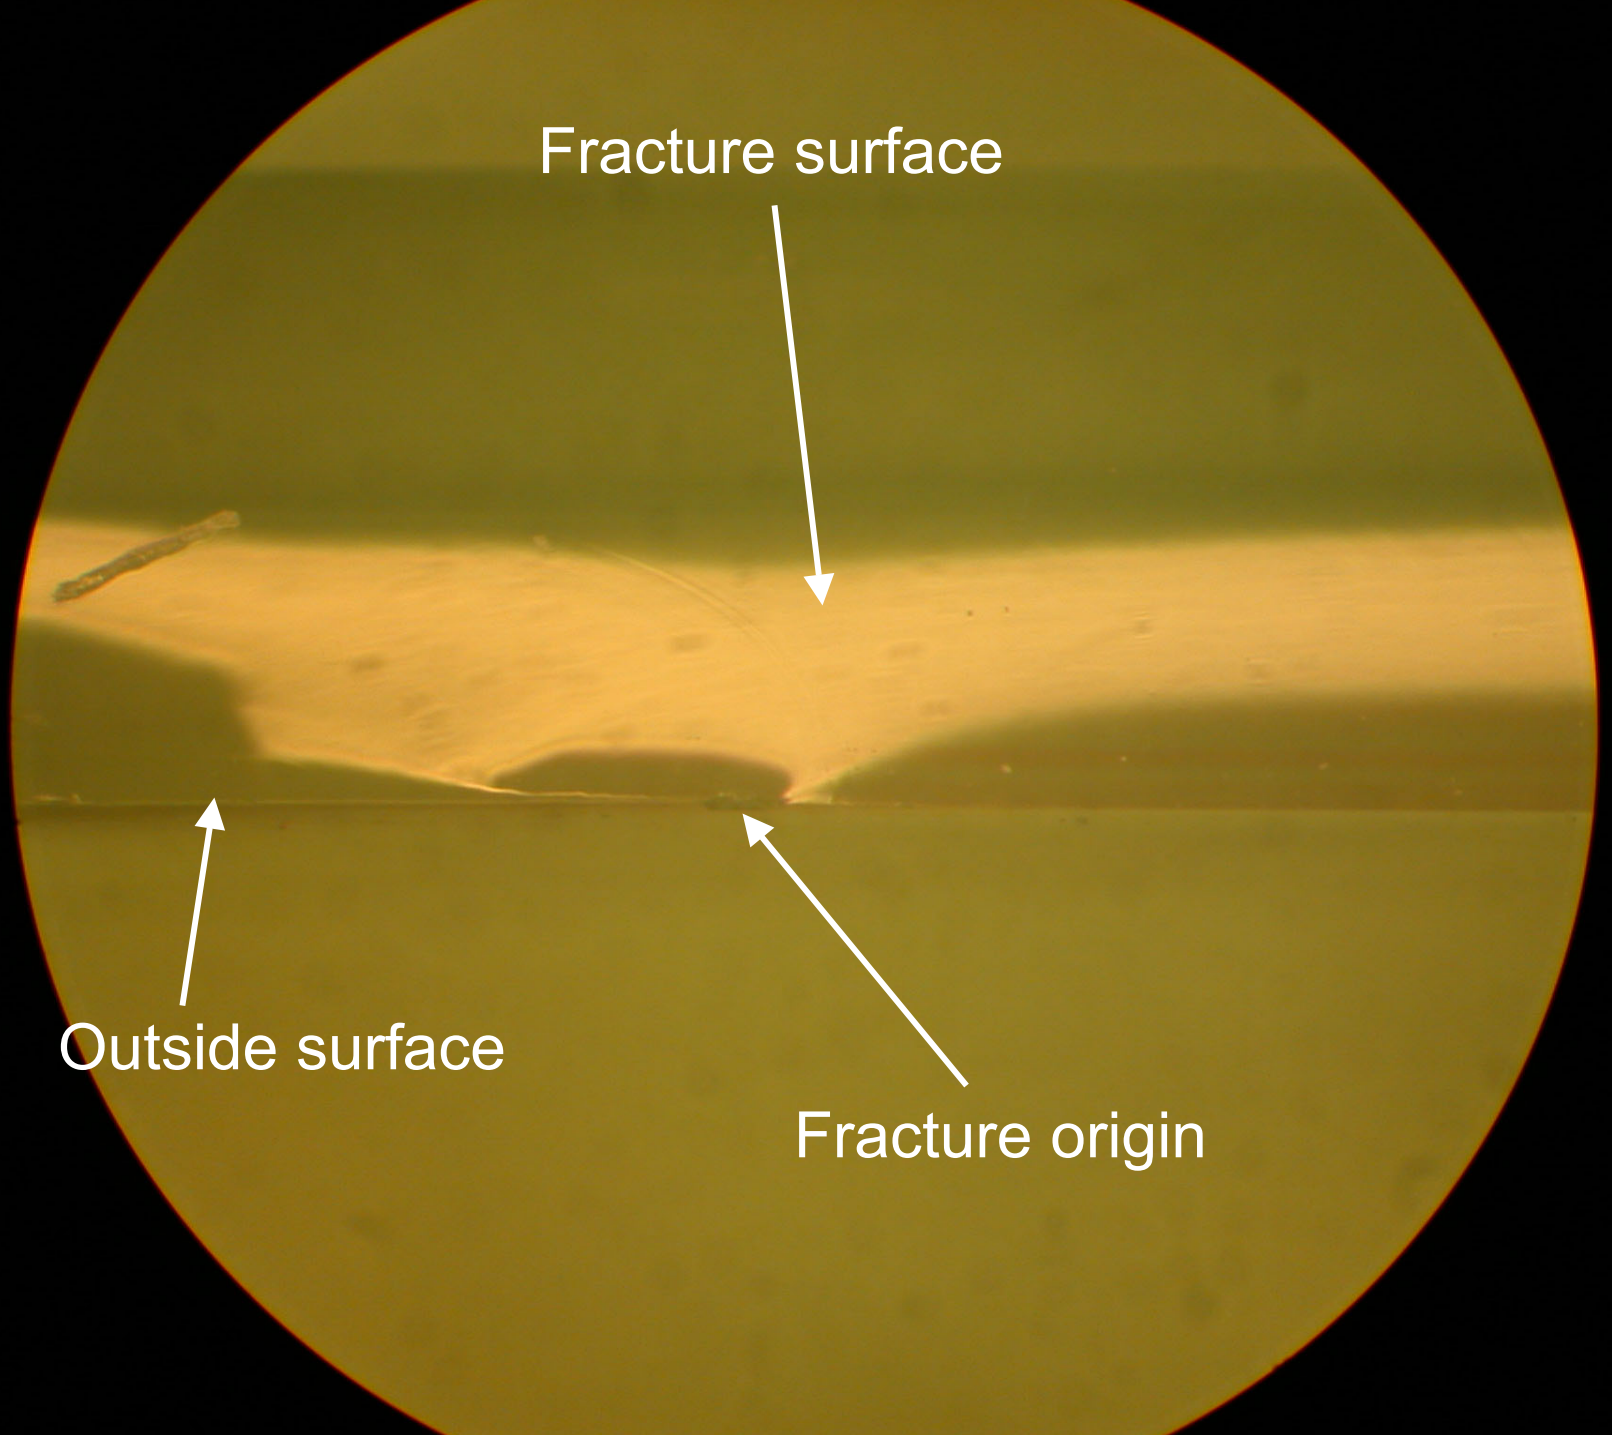
Fracture surface

Outside surface

Fracture origin

Wallner lines

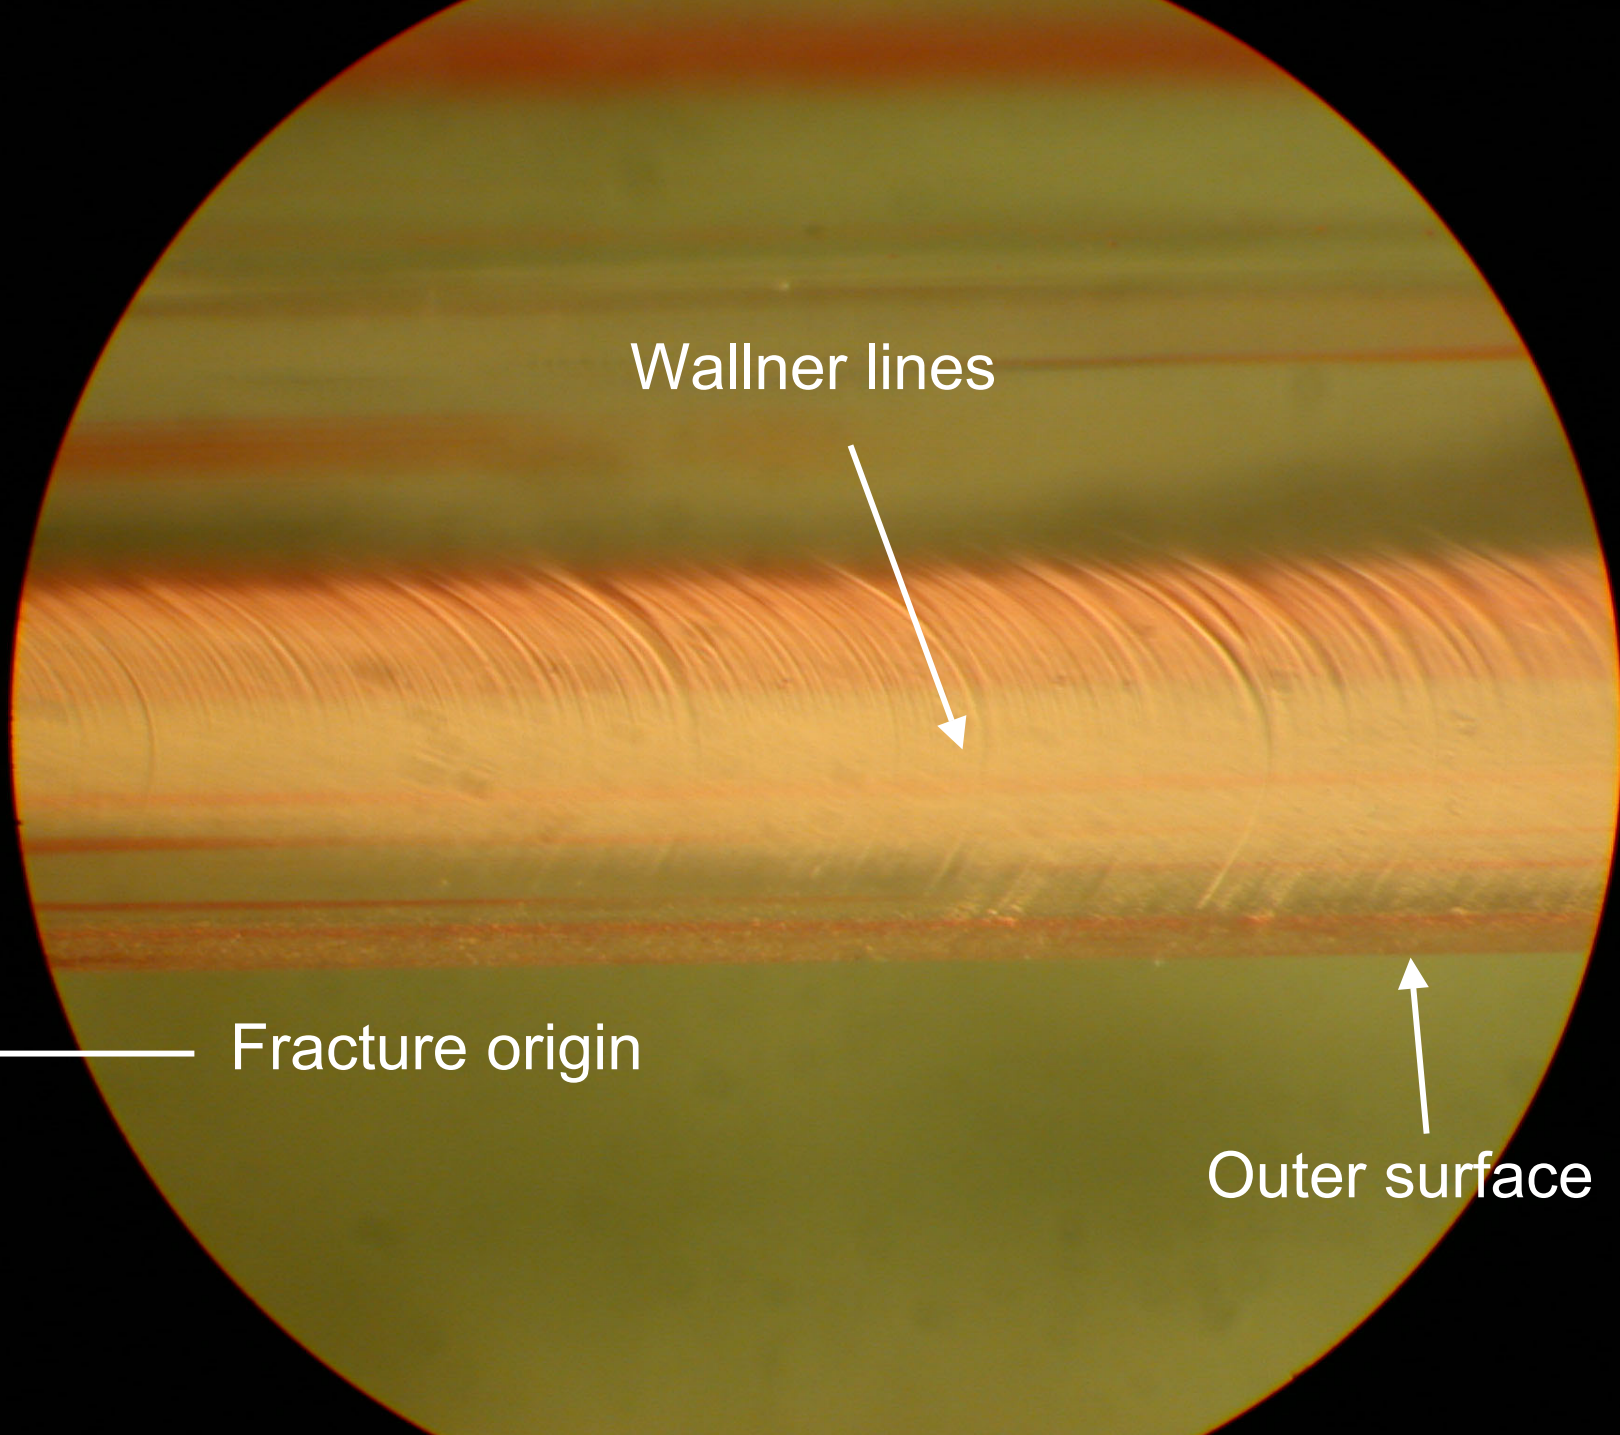
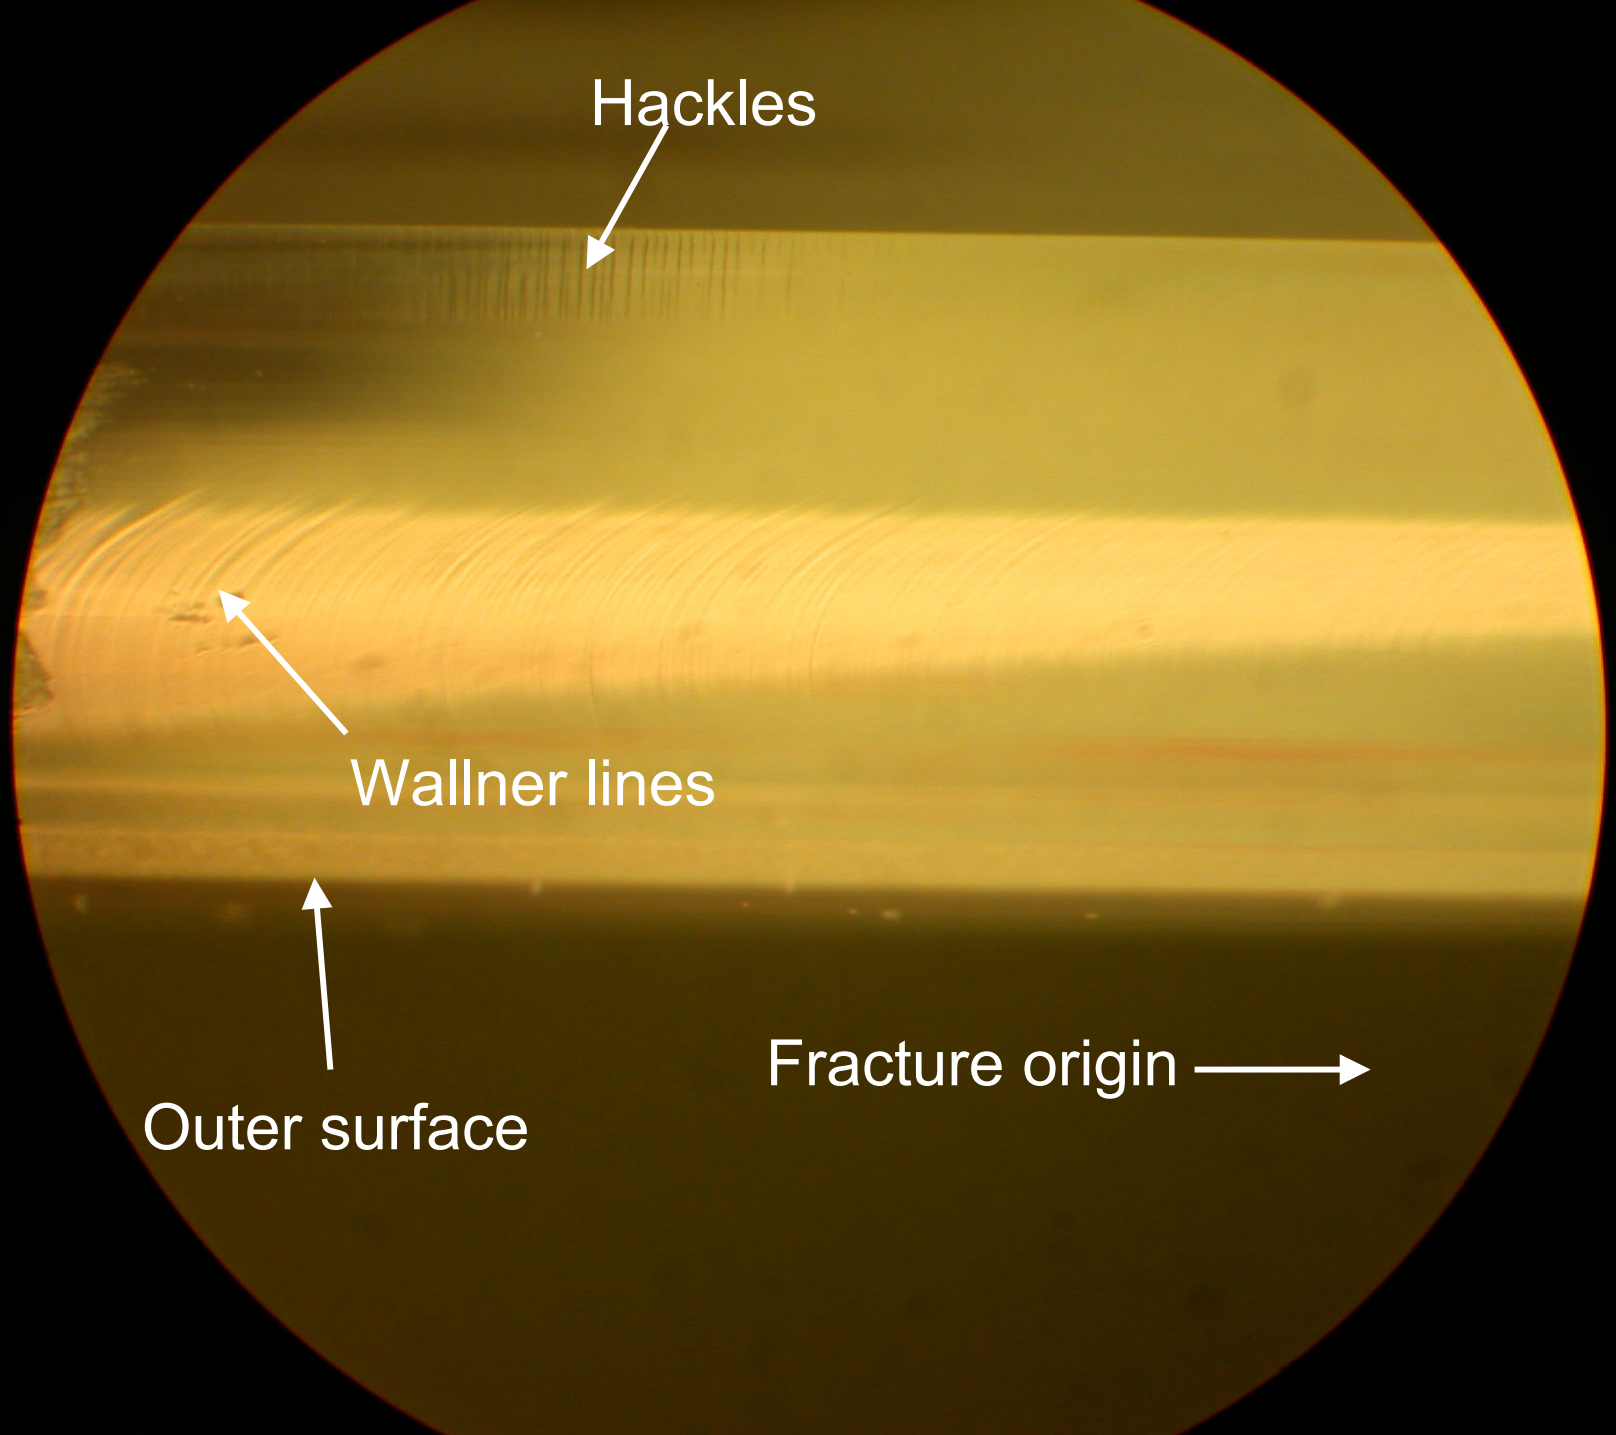
Hackles

Wallner lines

Outer surface

Fracture origin

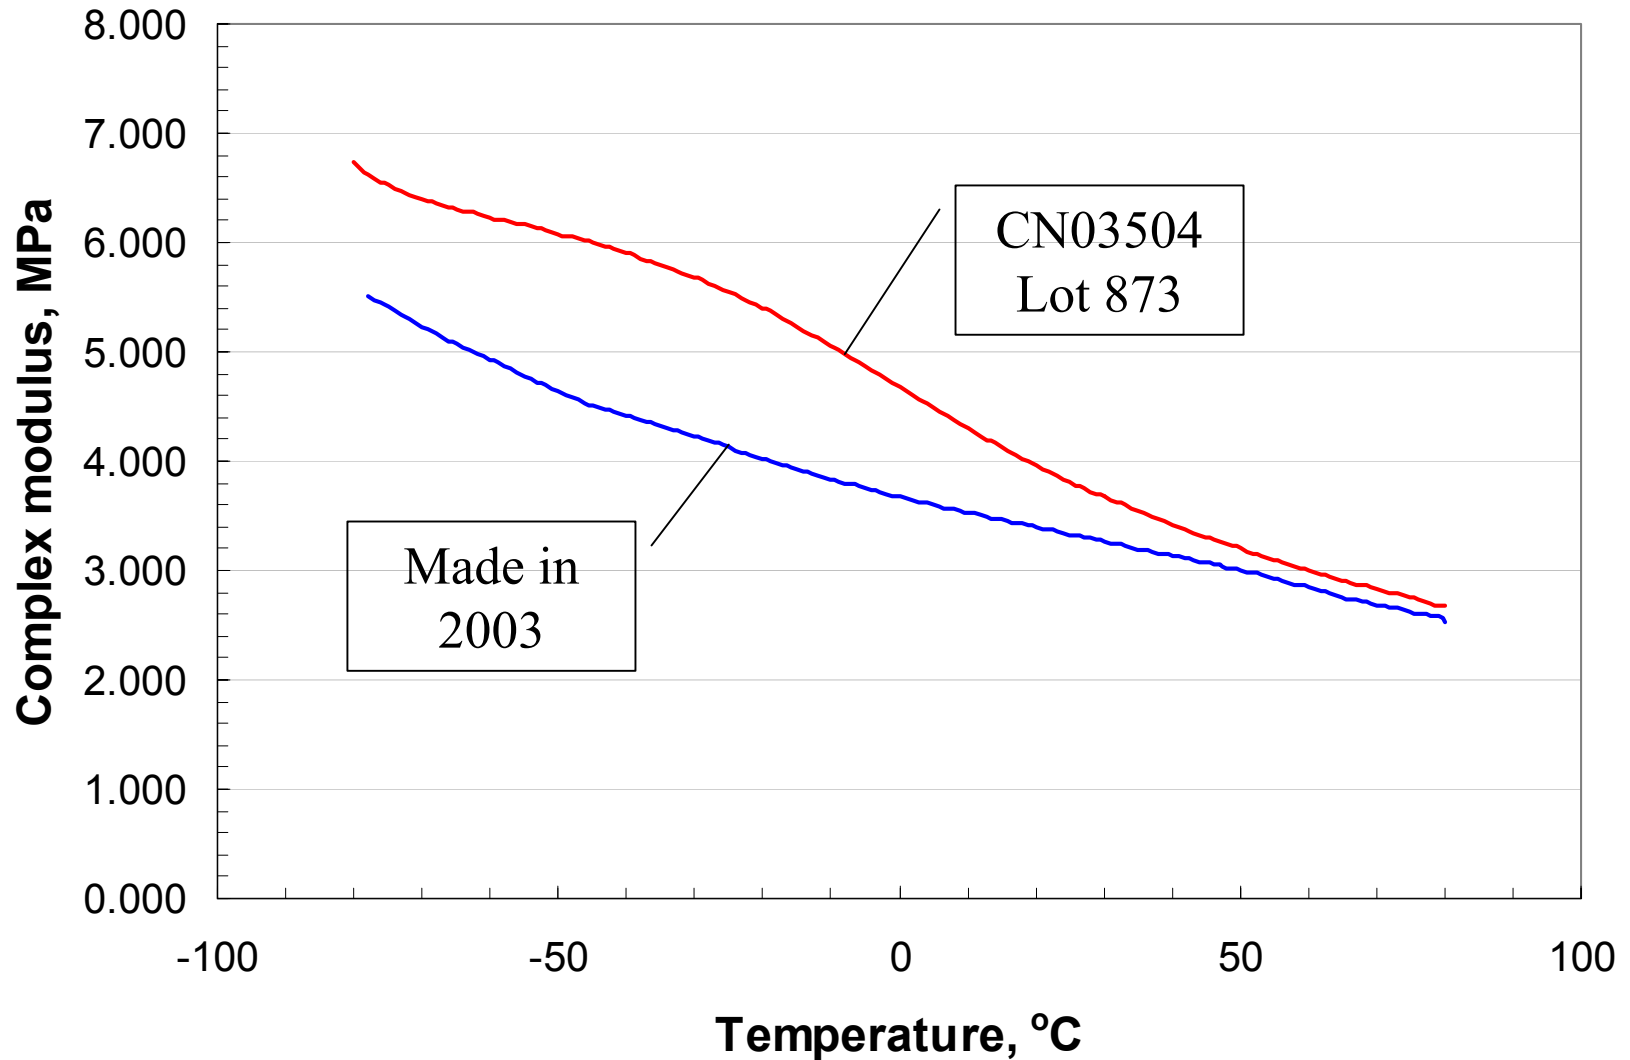
Modulus of RTV566

- Both failed NG tubes (AA0393 & ZL1193, 12 cycles between -30°C and +45°C) fractured from outside surface flaws
- Modulus of RTV varies between lots, but not significantly.
- Curing shrinkage about 0.2% (volume), mostly in the first 24 hrs.
